ACCIDENT REPORT FATAL FACTS

ACCIDENT SUMMARY No. 11

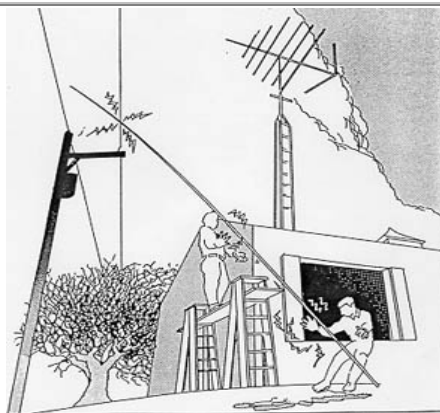
Two employees were installing aluminum siding on a farmhouse when it became necessary to remove a 36-foot high metal pole CB antenna. One employee stood on a metal pick board between two ladders and unfastened the antenna at the top of the house. The other employee, who was standing on the ground, took the antenna to lay it down in the yard. The antenna made electrical contact with a 7200-volt power transmission line 30 feet 10 inches from the house and 23 feet 9 inches above the ground. The employee handling the antenna received a fatal shock and the other employee a minor shock.

Following its investigation, OSHA issued one citation for two alleged serious violations of its construction standards. Had these standards been adhered to, the fatality might have been prevented.

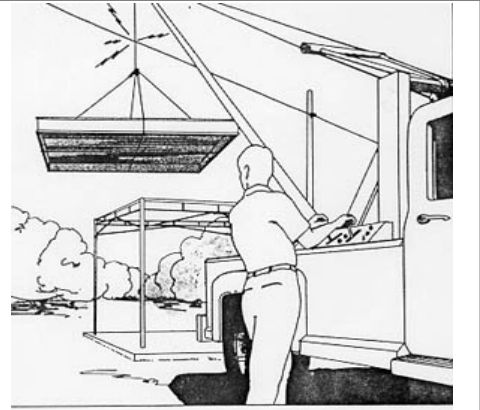
Employees were moving a steel canopy structure using a "boom crane" truck. The boom cable made contact with a 7200 volt electrical power distribution line electrocuting the operator of the crane; he was the foreman at the site.

As a result of its investigation, OSHA issued citations for four serious violations of its construction standards dealing with training, protective equipment, and working too close to power lines. OSHA's construction safety standards include several requirements which, if they had been followed here, might have prevented this fatality.

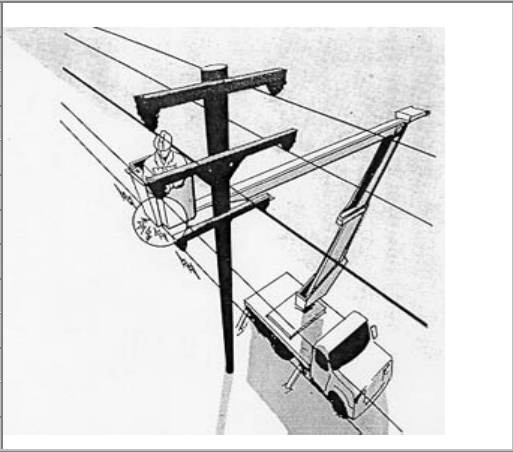
A lineman was electrocuted while working on grounded de-energized lines. He was working from a defective basket on an articulated boom aerial lift when the basket contacted energized lines which ran beneath the de-energized lines. The defective basket permitted current to pass through a drain hole cut into the body of the basket, then through the employee, and to ground via the de-energized line.

OSHA cited the company for two serious violations and one other than serious violation of its construction standards. Had barriers been erected to prevent contact with adjacent energized lines, the electrical shock might have been prevented.

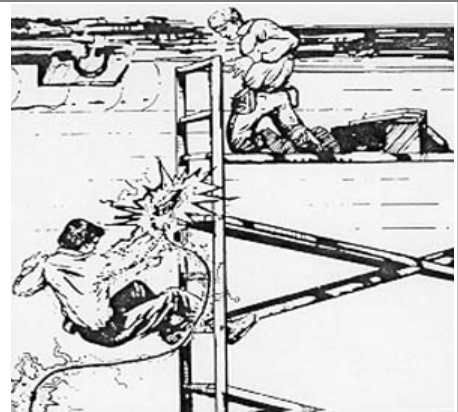
One employee was climbing a metal ladder to hand an electric drill to the journeyman installer on a scaffold about five feet above him. When the victim reached the third rung from the bottom of the ladder he received an electric shock that killed him. The investigation revealed that the extension cord had a missing grounding prong and that a conductor on the green grounding wire was making intermittent contact with the energizing black wire thereby energizing the entire length of the grounding wire and the drill's frame. The drill was not double insulated.

As a result of its investigation, OSHA issued citations for violations of construction standards.
