ACCIDENT REPORT FATAL FACTS

ACCIDENT SUMMARY No. 2

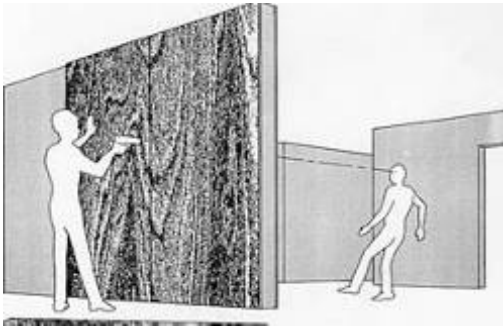
Accident Type:	Struck by Nail

A carpenter apprentice was killed when he was struck in the head by a nail that was fired from a powder actuated tool. The tool operator, while attempting to anchor a plywood form in preparation for pouring a concrete wall, fired the gun causing the nail to pass through the hollow wall. The nail travelled some twenty-seven feet before striking the victim. The tool operator had never received training in the proper use of the tool, and none of the employees in the area were wearing personal protective equipment.

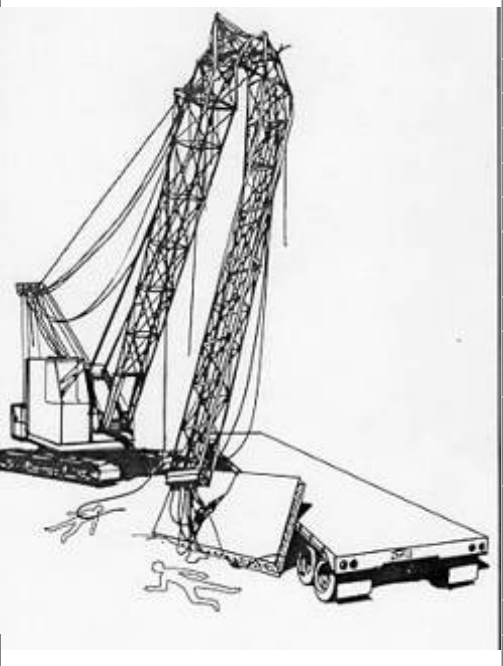
ACCIDENT SUMMARY No. 4

Accident Type:	Struck by Collapsing Crane Boom

A crew of ironworkers and a crane operator were unloading a 20-ton steel slab from a low-boy trailer using a 50-ton crawler crane with 90-foot lattice boom. The operator was inexperienced on this crane and did not know the length of the boom. Further, no one had determined the load radius. During lifting, the load moved forward and to the right, placing a twisting force on the boom. The boom twisted under the load, swinging down, under and to the right. Two employees standing 30 feet away apparently saw the boom begin to swing and ran. The boom struck one of the employees - an ironworker - on the head, causing instant death. Wire rope struck the other -- a management trainee -- causing internal injuries. He died two hours later at a local hospital.

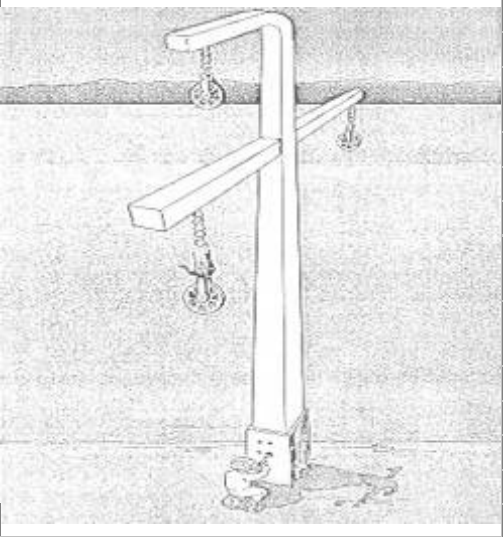
ACCIDENT SUMMARY No. 8

Accident Type:	Struck by Falling Object

Ball and socket connectors are used to attach conductor stringing blocks to insulators on the arms of 90 foot metal towers of electrical transmission lines. Normally stainless steel cotter keys secure the ball and socket connector in place. In this case, however, black electrical tape was wrapped around the socket to keep the ball in place rather than a cotter key. The tape apparently stretched and the ball came loose, dropping the stringing block approximately 90 feet onto the head of an employee below, one of a four-man erection crew.

As result of the its investigation, OSHA issued citations alleging three serious and two other-than-serious violations.

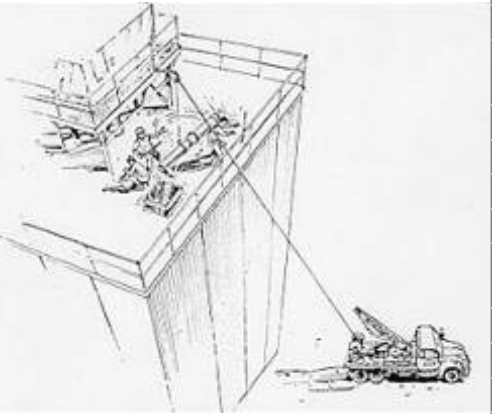
ACCIDENT SUMMARY No. 51

Accident Type:	Struck By

Employees were dismantling grain spouts at a grain elevator. Sections of the spout were connected by collars. A ten foot section of a spout weighing 600 pounds was being pulled through a vent hole by a 5-ton winch. As the spout was being pulled through the opening to the outside, the spout became wedged at the point where the collar was to pass through. Several employees used pry bars to free the collar which was under tension. The spout popped out of the vent striking and killing an employee who was standing beside the spout. * Employer provided but did not require use of hard hats.

As a result of its investigation, OSHA issued two citations alleging serious violations. The employee should have been able to recognize that this situation was hazardous. Additionally, the investigation revealed that this employee was not wearing personal protective equipment in this hazardous situation. Had he been wearing a hard hat this death might have been prevented.
